Manual for charger interface type KM-RI for KraftMaster

KM-RI provides an interface between the monitoring unit KM-BAS and a charger through the local bus, KraftNet. Its duty is to measure rectifier current, distribute charger alarms, set the temperature compensated charge voltage and select charge voltage level for float charge, battery test and equalizing charging. KM-RI is needed in UNIQ systems with chargers working in parallel and in KM-19" systems.

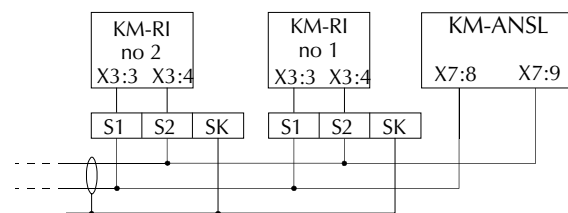
If the system has chargers working in parallel, that is more than one KM-RI unit is used, all the KraftNet connections should be connected in parallel, see figure.
